**Flood Control Project Maintenance
Levee Inspections**

Maintenance Issue Types Only, Levee Inspection Report By Mile - Fall 2016

Reclamation District No. 1000 Natomas

Waterway	Bank	Unit Miles	Inspection Start/End	Inspector
Unit No. 01 Sacramento River	Left	18.28	09/13/2016 09/14/2016	Sterling York

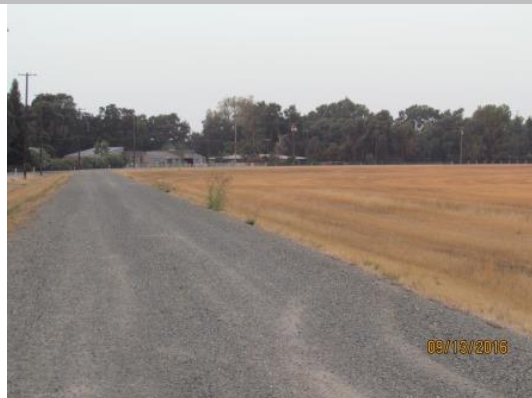
Photo 1 of 1 : FA_2016_RD1000_31_88_20160919_00051.jpg

LM Start	0.00	Rating **	A	Issue No.	88
LM End	12.30	Issue Type +	Ma	Location *	LS
Category	Earthen Levee		GPS Latitude/Longitude		
			Start	End	
Item	Vegetation		38.780502°	38.649896°	
			-121.603437°	-121.571261°	
DWR ID	DWR_RD1000_01_f_2016_88				
Comment Code					
V1 : Control annual grass and weeds on the levee slopes and easements.					
Inspector Comment					
The Levee has no unwanted vegetation blocking visibility or access. The annual grasses are mowed making the slopes visible and accessible.

View looking upstream landside of maintained annual grasses.

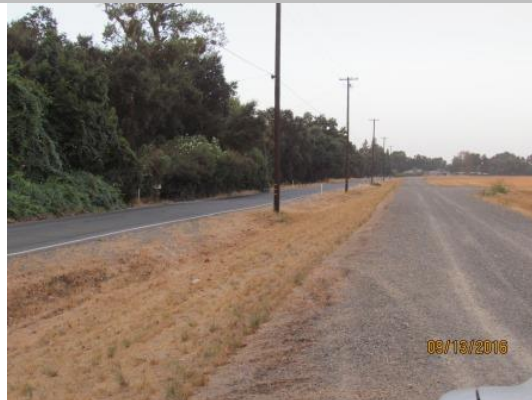
Photo 1 of 1 : FA_2016_RD1000_31_77_20160919_00050.jpg

LM Start	0.00	Rating **	A	Issue No.	77
LM End	12.30	Issue Type +	Ma	Location *	WS
Category	Earthen Levee		GPS Latitude/Longitude		
			Start	End	
Item	Vegetation		38.780502°	38.649896°	
			-121.603437°	-121.571262°	
DWR ID	DWR_RD1000_01_f_2016_77				
Comment Code					
V1 : Control annual grass and weeds on the levee slopes and easements.					
Inspector Comment					
The Levee has no unwanted vegetation blocking visibility or access. The annual grasses are mowed making the slopes visible and accessible.

View looking upstream waterside of maintained annual grasses.

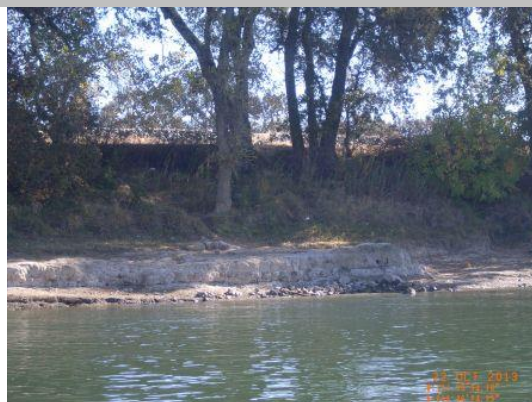
Photo 1 of 1 : FA_2016_RD1000_31_3_20160906_00003.jpg

LM Start	0.48	Rating **	M	Issue No.	3
LM End	0.61	Issue Type +	Ma	Location *	WS
Category	Supplemental			GPS Latitude/Longitude	
				Start	End
Item	2015 USACE Erosion Survey, DRAFT			38.774507 °	38.772921 °
				-121.598865 °	-121.597788 °
DWR ID	DWR_RD1000_01_s_2016_3				
Comment Code					
Inspector Comment					
1997 - Very cohesive toe. 2005 - Site was staked and rock was stockpiled along the top of the bank. 2010 - New adjacent levee under construction. 2011 - New animal burrow. 2015: No observed changes. [2015 Site ID: SAC_78-3_L]

USACE 2013 Photo #1

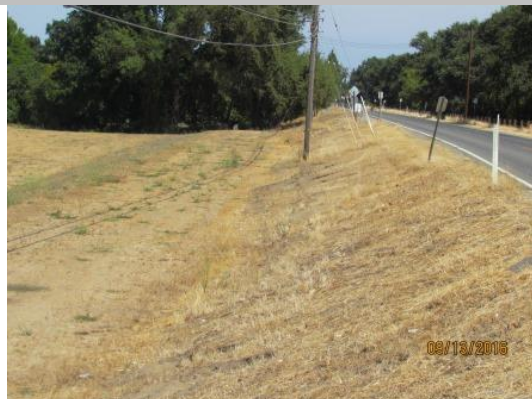
Photo 1 of 1 : FA_2016_RD1000_31_97_20160919_00066.jpg

LM Start	12.30	Rating **	A	Issue No.	97
LM End	18.08	Issue Type +	Ma	Location *	LS
Category	Earthen Levee			GPS Latitude/Longitude	
				Start	End
Item	Vegetation			38.649896 °	38.603918 °
				-121.571262 °	-121.514370 °
DWR ID	DWR_RD1000_01_f_2016_97				
Comment Code					
V1 : Control annual grass and weeds on the levee slopes and easements.					
Inspector Comment

View looking downstream landside of maintained annual grasses.

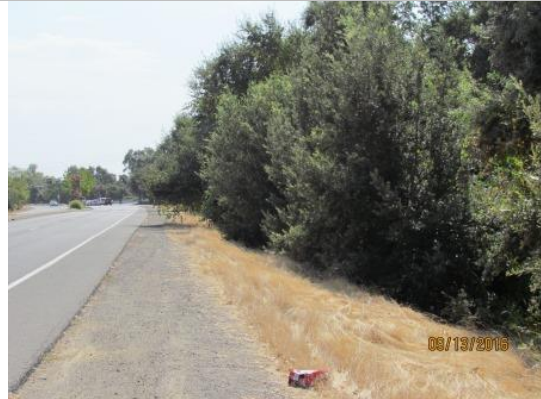
Photo 1 of 1 : FA_2016_RD1000_32_3_20160919_00005.jpg

LM Start	1.79	Rating **	M	Issue No.	3
LM End	2.07	Issue Type +	Ma	Location *	WS
Category	Earthen Levee			GPS Latitude/Longitude	
				Start	End
Item	Trim / Thin Trees			38.606566°	38.605012°
				-121.479695°	-121.474813°
DWR ID	DWR_RD1000_02_f_2016_3				
Comment Code					
T1 : Trim trees to at least five feet above ground level.					
Inspector Comment					
Trees need to be trimmed. Fall 2016.

View looking upstream waterside of trees that need to be trimmed. Fall 2016.

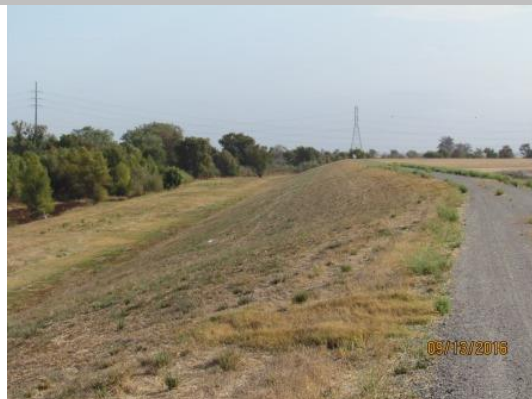
Photo 1 of 1 : FA_2016_RD1000_33_6_20160914_00015.jpg

LM Start	0.09	Rating **	A	Issue No.	6
LM End	16.66	Issue Type +	Ma	Location *	WS
Category	Earthen Levee			GPS Latitude/Longitude	
				Start	End
Item	Vegetation			38.606882 °	38.823080 °
				-121.469480 °	-121.539803 °
DWR ID	DWR_RD1000_03_f_2016_6				
Comment Code					
V1 : Control annual grass and weeds on the levee slopes and easements.					
Inspector Comment					
Annual grasses have been mowed.

View waterside looking upstream of maintained vegetation.

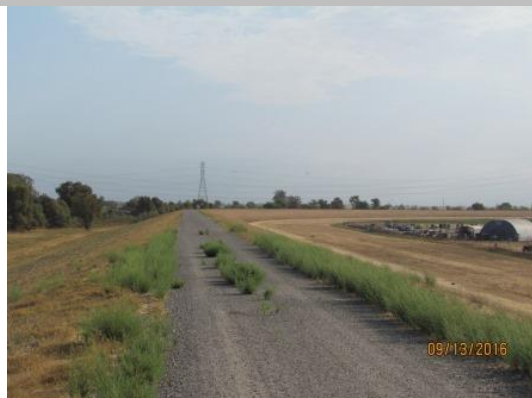
Photo 1 of 1 : FA_2016_RD1000_33_11_20160915_00023.jpg

LM Start	0.09	Rating **	A	Issue No.	11
LM End	16.66	Issue Type +	Ma	Location *	LS
Category	Earthen Levee			GPS Latitude/Longitude	
				Start	End
Item	Vegetation			38.606882 °	38.823080 °
				-121.469480 °	-121.539804 °
DWR ID	DWR_RD1000_03_f_2016_11				
Comment Code					
V1 : Control annual grass and weeds on the levee slopes and easements.					
Inspector Comment					
Annual grasses have been mowed and all new growth was being sprayed 9/13/16.

View looking upstream landside of the mowed annual grass.

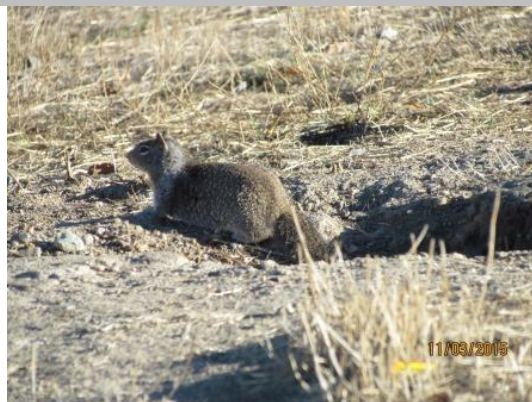
Photo 1 of 2 : FA_2016_RD1000_33_19_20160906_00013.jpg

LM Start	0.38	Rating **	A/W	Issue No.	19
LM End	0.38	Issue Type +	Ma	Location *	LS
Category	Earthen Levee			GPS Latitude/Longitude	
				Start	End
Item	Animal Control			38.610854 °	38.610854 °
				-121.467961 °	-121.467961 °
DWR ID	DWR_RD1000_03_f_2015_19				
Comment Code					
A1 : Exterminate rodents and backfill and compact or grout burrows.					
Inspector Comment					
Bait injection into rodent hole for control. No sign of rodents Fall 2016.

View of the rodent on the waterside levee slope ready to retreat into the den, penetrating the levee prism.

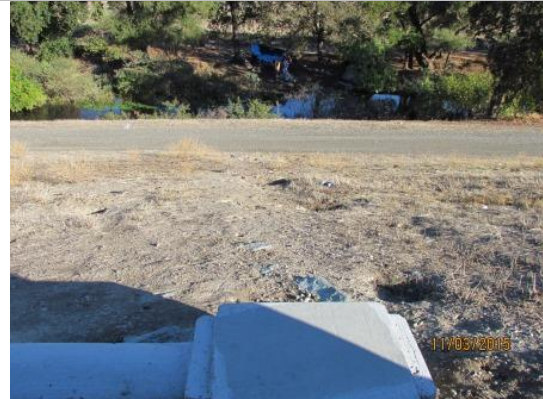
Photo 2 of 2 : FA_2016_RD1000_33_19_20160906_00014.jpg

LM Start	0.38	Rating **	A/W	Issue No.	19 (cont)	
LM End	0.38	Issue Type +	Ma	Location *	LS	
Category	Earthen Levee			GPS Latitude/Longitude		
				Start	End	
Item	Animal Control			38.610854 °	38.610854 °	
				-121.467961 °	-121.467961 °	
DWR ID	DWR_RD1000_03_f _ 2015_19					
Comment Code						
A1 : Exterminate rodents and backfill and compact or grout burrows.						
Inspector Comment						
Bait injection into rodent hole for control. No sign of rodents Fall 2016.

View of the rodent holes on the waterside levee slope. Fall 2015. Bait injection into rodent hole for control, no sign of rodents Fall 2016.

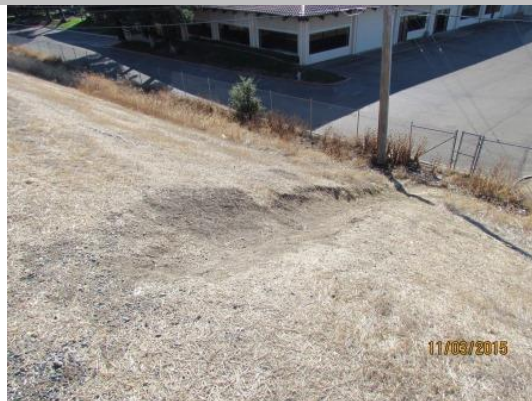
Photo 1 of 1 : FA_2016_RD1000_33_15_20160906_00012.jpg

LM Start	2.36	Rating **	M	Issue No.	15
LM End	2.36	Issue Type +	Ma	Location *	LS
Category	Earthen Levee			GPS Latitude/Longitude	
				Start	End
Item	Slope Stability			38.639326°	38.639326°
				-121.473107°	-121.473107°
DWR ID	DWR_RD1000_03_f_2015_15				
Comment Code					
S2 : Repair the levee slope damaged by foot traffic and prevent access where possible.					
Inspector Comment

View of the landside levee slope damaged by foot traffic.

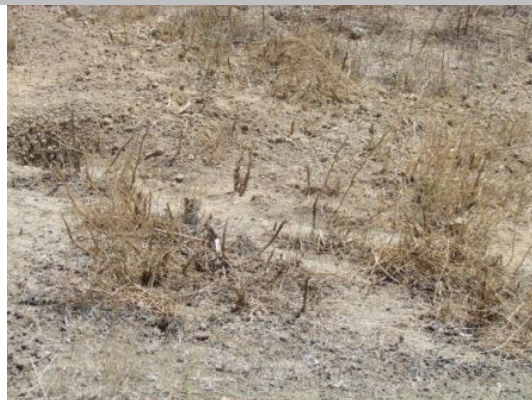
Photo 1 of 2 : FA_2016_RD1000_33_1_20160906_00003.jpg

LM Start	4.78	Rating **	A/W	Issue No.	1
LM End	4.89	Issue Type +	Ma	Location *	LS
Category	Earthen Levee			GPS Latitude/Longitude	
				Start	End
Item	Animal Control			38.672913 °	38.673685 °
				-121.481364 °	-121.483115 °
DWR ID	DWR_RD1000_03_f_2013_1				
Comment Code					
A1 : Exterminate rodents and backfill and compact or grout burrows.					
Inspector Comment					
Several bait traps line the levee toe, no sign of rodents.

This photo was taken from the levee crown looking down the landward slope at a squirrel poking its head out of a hole. Fall 2014.

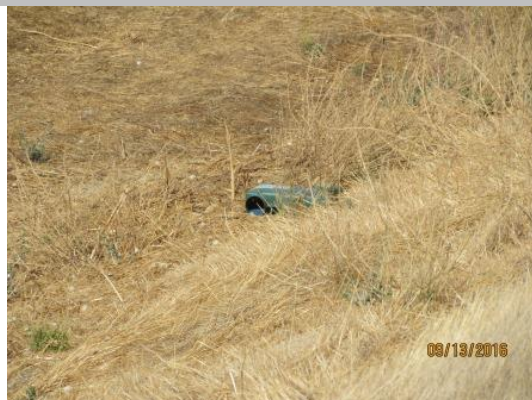
Photo 2 of 2 : FA_2016_RD1000_33_1_20160914_00020.jpg

Updated view taken facing the landside looking upstream at bait trap. Rodent holes have been filled and no new activity was observed. Several bait traps at landside levee toe. Fall 2016.

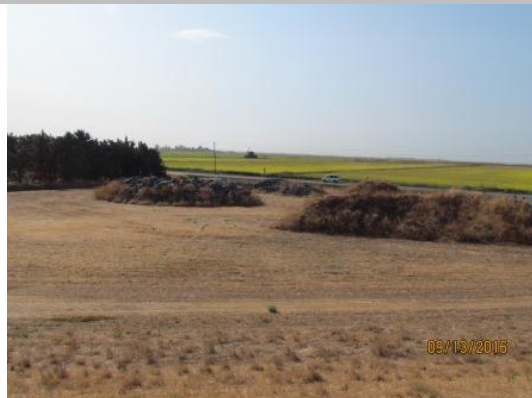
Photo 1 of 1 : FA_2016_RD1000_33_21_20160914_00017.jpg

LM Start	16.52	Rating **	A	Issue No.	21
LM End	16.52	Issue Type +	Ma	Location *	LS
Category	Earthen Levee			GPS Latitude/Longitude	
				Start	End
Item	Emergency Supplies & Equipment			38.824246°	38.824246°
				-121.537720°	-121.537720°
DWR ID	DWR_RD1000_03_f_2016_21				
Comment Code					
Inspector Comment

View of stockpiled flood fight material on landside.
